Ceramic Applications in Turbine Engines

Harold E. Helms, Peter W. Heitman,
Leonard C. Lindgren, and Samuel R. Thrasher
Allison Gas Turbine Division
General Motors Corporation

October 1984

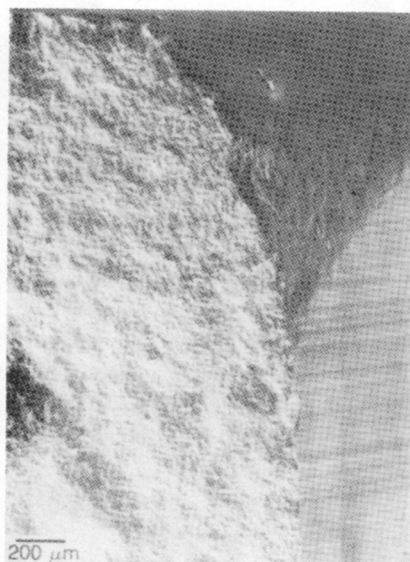
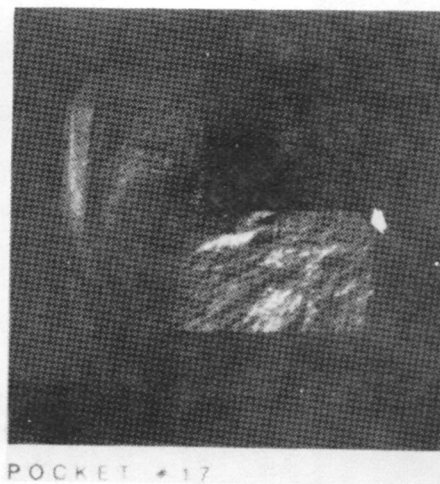
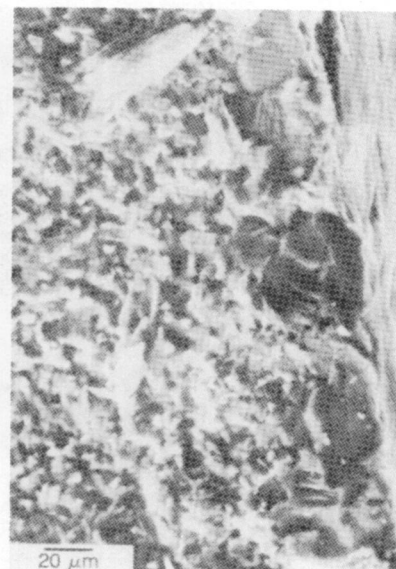
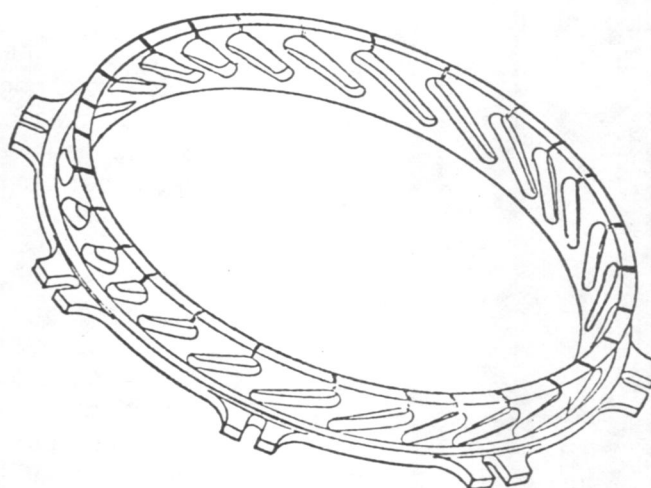
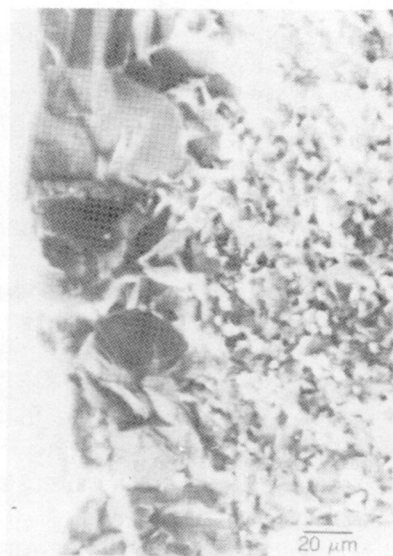
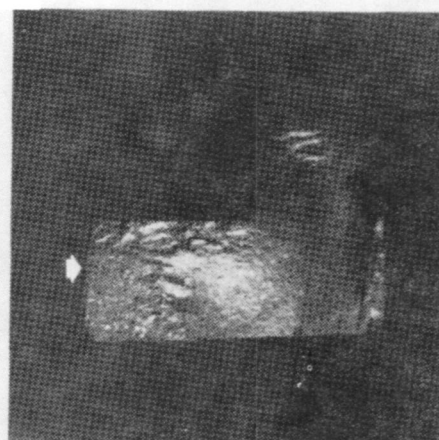
Figure 274. Failure origin of outer vane support ring (S/N FX 25830) during BU9 of the thermal shock rig.

Inspection of the assembly revealed the outer vane support ring cracked in two places. Examination of the fracture surfaces revealed a low strength silicon carbide layer (approximately 80 μm thick) similar to that observed during bladder-proof testing, as shown in Figure 274. The failure origins are at the leading edge of the outside diameter flange, corresponding to the peak calculated stress location. The failure at pocket No. 3 is considered the primary failure because of the larger fracture mirror. This ring had previously been bladder-proof tested to 5170 kPa (750 lb/in.²), corresponding to 55.2 MPa (8 ksi) stress on the flange, which indicates that the transient stress is higher than 55.2 MPa (8 ksi). The instrumented nozzle analysis presented earlier predicted a transient stress of 137.9 MPa (20.0 ksi).

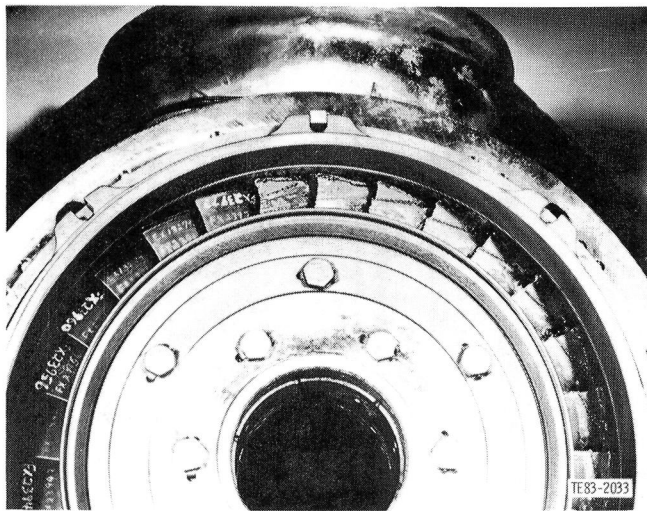
During BU10 of the thermal shock rig, the rig was operated through the first phase of testing (slow heat up, stabilization, and slow cool-down). On inspection of the ceramic parts, a foreign substance was seen on the vanes and rings (see Figures 275 and 276). The assembly was removed for a closer inspection.

Figure 275. View of nozzle assembly after removal from thermal shock rig BU10.

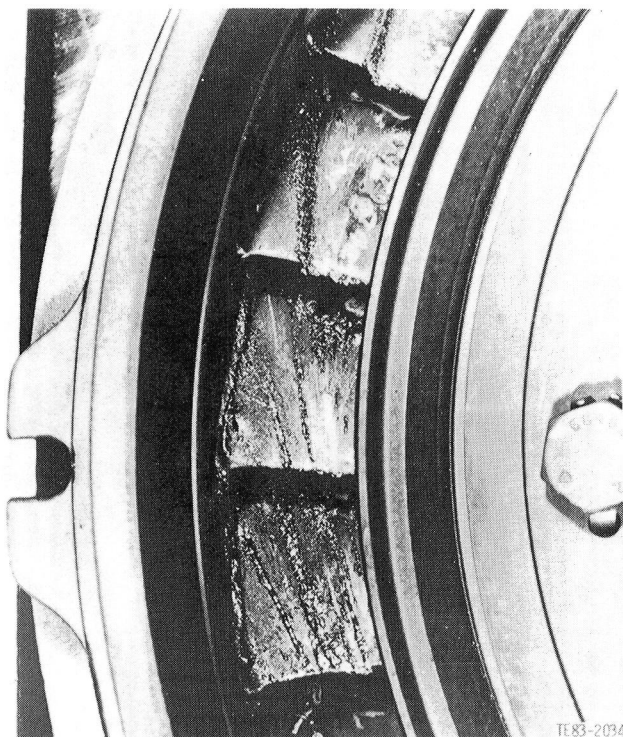
Figure 276. Close-up of silicon attached to vanes after testing in BU10 of the thermal shock rig.

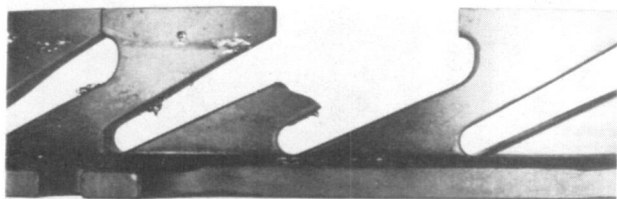
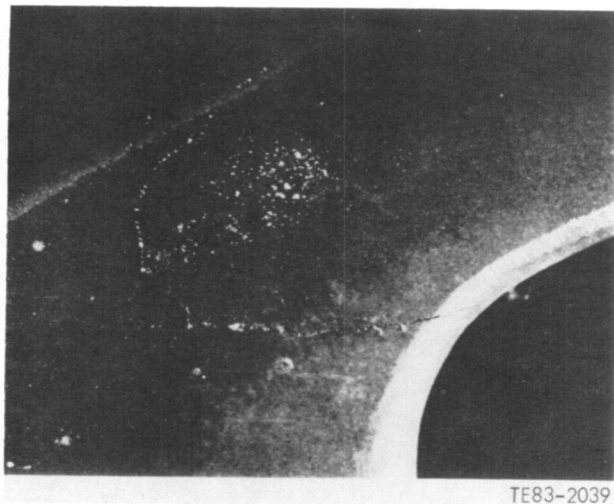
Inspection of the outer vane support ring revealed some cracks between the lug slots, shown in Figure 281, and areas of superficial porosity where the silicon had exuded. Figure 282 shows a cross section of the outer vane support ring at the crack in a lug slot. Area 1 shows the SiC crystals without any free silicon present. Area 2 shows the microstructure when the free silicon is beginning to melt. Area 3 shows a typical microstructure of RBSiC. Area 4 shows the silicon bubbling out on the surface of the ring. Area 5 shows the microstructure where some free silicon had exuded and the rest was melted. Inspection of the inner vane support ring reveals a small area of superficial porosity at the trailing edge of two vane pockets. Inspection of the shroud did not reveal any damage due to overtemperature.

Figure 281. Outer vane support ring (S/N FX 25834) with portion of vane retention feature missing after testing in BU10 of the thermal shock rig (top); close-up of crack in another vane slot of outer vane support ring (S/N FX 25834) (bottom).

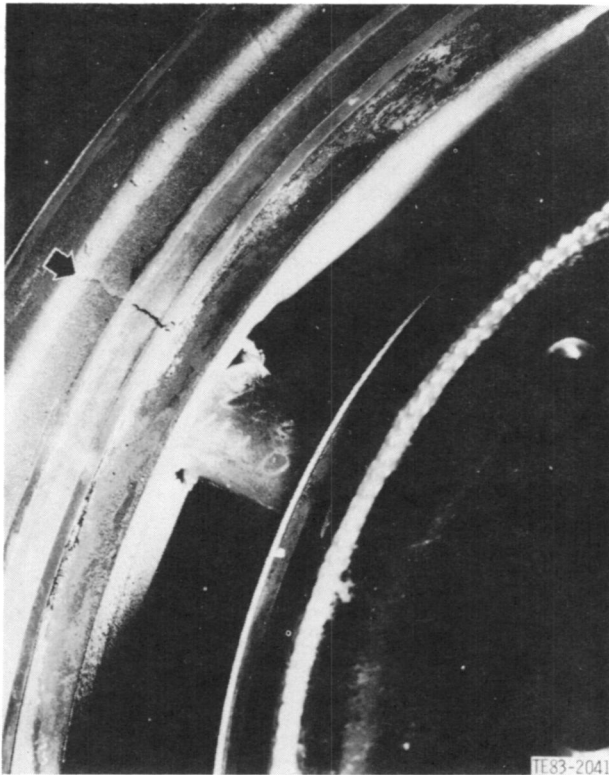
There was some difficulty in disassembling the ceramic nozzle assembly because the metal support structure had distorted and locked up the locating tabs on the shroud and the outer vane support ring. After disassembly, the metal outer support was found to be distorted with a crack starting at the inner diameter, as shown in Figure 283.

Investigation into the cause of the overtemperature revealed the failure of two airflow reference thermocouples. This resulted in an erroneous fuel/air temperature calculation that caused overtemperature operation. At the same time, four of eight plenum thermocouples failed, which resulted in a measured temperature average that agreed with the erroneous fuel/air temperature. Following the inadvertent overtemperature, the procedures for the next build of the thermal shock rig were reviewed and revised. The revisions included additional checks on temperature and verification of fuel/air ratio. Several

Figure 283. Close-up of crack in metal outer support due to overtemperature in thermal shock rig BU10.

temperature limiters and a fuel-flow limiter were incorporated to prevent an overtemperature condition from happening.

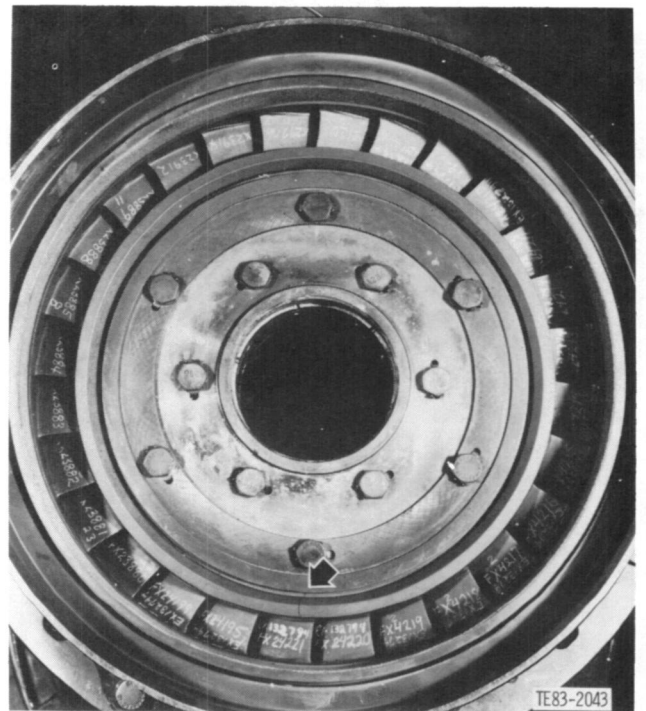
The second phase included five complete qualification slow acceleration cycles, including a sharp acceleration, the 8 minute stabilization, and an exponential deceleration. At the conclusion of this phase, the RBSiC inner vane support ring was cracked in one place, as shown in Figure 285. Tear-

Figure 285. View of gasifier nozzle assembly from rear, showing crack in inner vane support ring after testing in thermal shock rig (BU12).

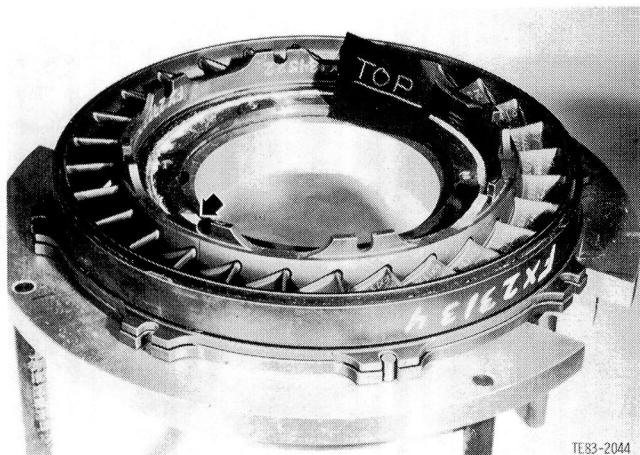
down of the assembly revealed that two lugs were also fractured on the inner vane support ring (see Figure 286). All other parts passed the posttest inspection and were considered qualified for 1132°C (2070°F) operation. These parts included an outer vane support ring without slots at the leading edge of each vane pocket.

Figure 286. Ceramic nozzle assembly for 2070°F-configuration after testing in thermal shock rig (BU12), showing lug fractures in the inner vane support ring.

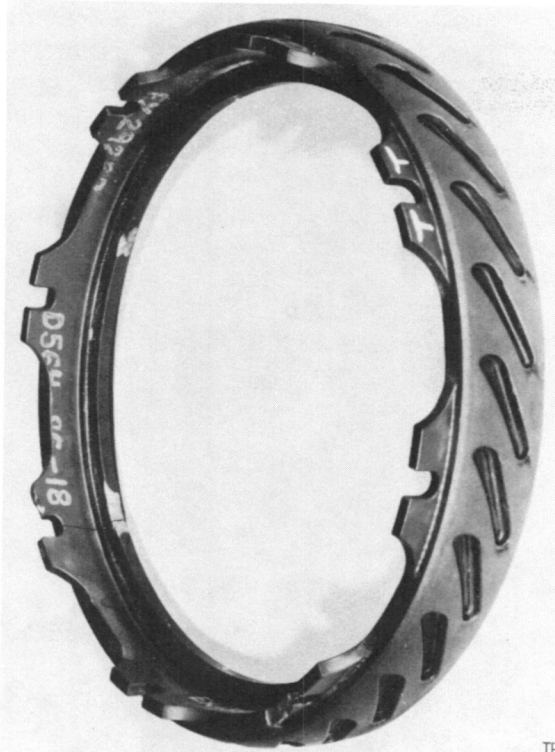
Closer examination of the failed inner vane support ring by the materials laboratory indicated that the crack originated at the flange inside diameter (shown in Figure 287), which is the predicted maximum stress location during an acceleration transient. Also, the inner flange is chipped in two locations (see Figure 288). One location is at the same

Figure 288. Inner vane support ring (S/N FX 29257) after testing in thermal shock rig (BU12) showing chipped areas at inner flange.

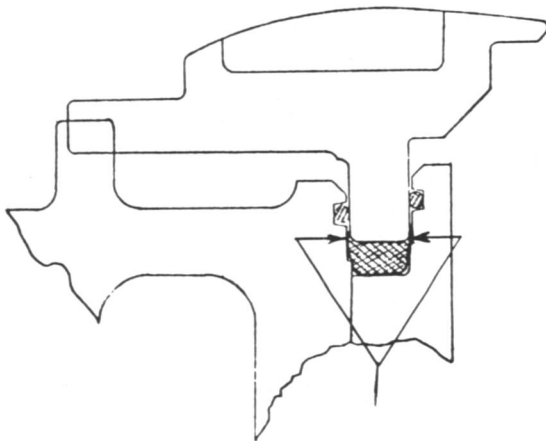
Area stressed by rope packing being clamped

Figure 289. Axial squeezing of large rope packing.

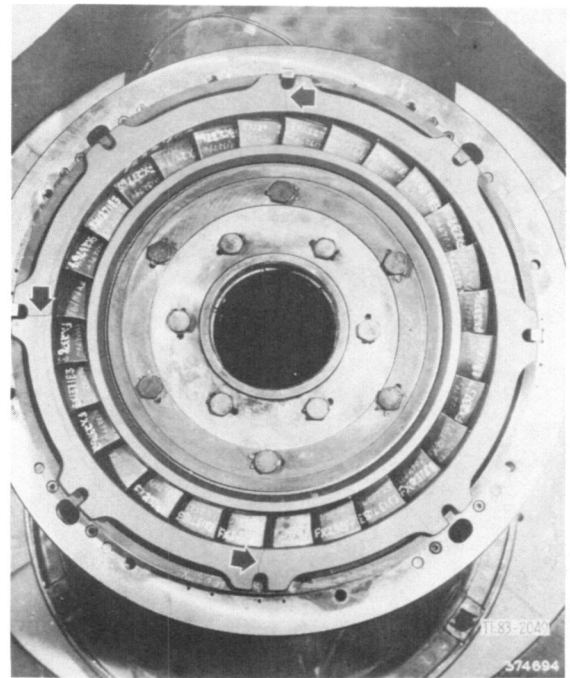
Figure 291. View of 2070°F-configuration gasifier nozzle assembly from rear, showing cracks in outer and inner vane support rings after testing in BU13 of the thermal shock rig.

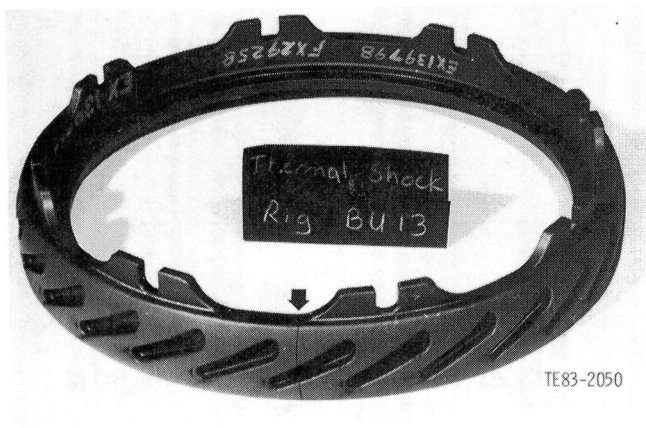
Figure 292. Inner vane support ring (S/N FX 29258) after testing in thermal shock rig (BU13), showing crack through ring.

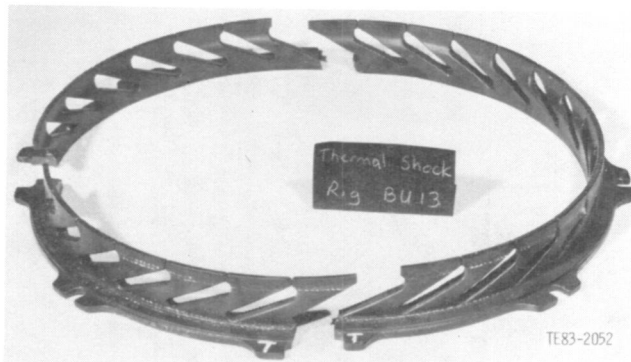
Figure 294. Outer vane support ring (S/N FX 28704) after testing in thermal shock rig (BU13), showing three cracks through ring.

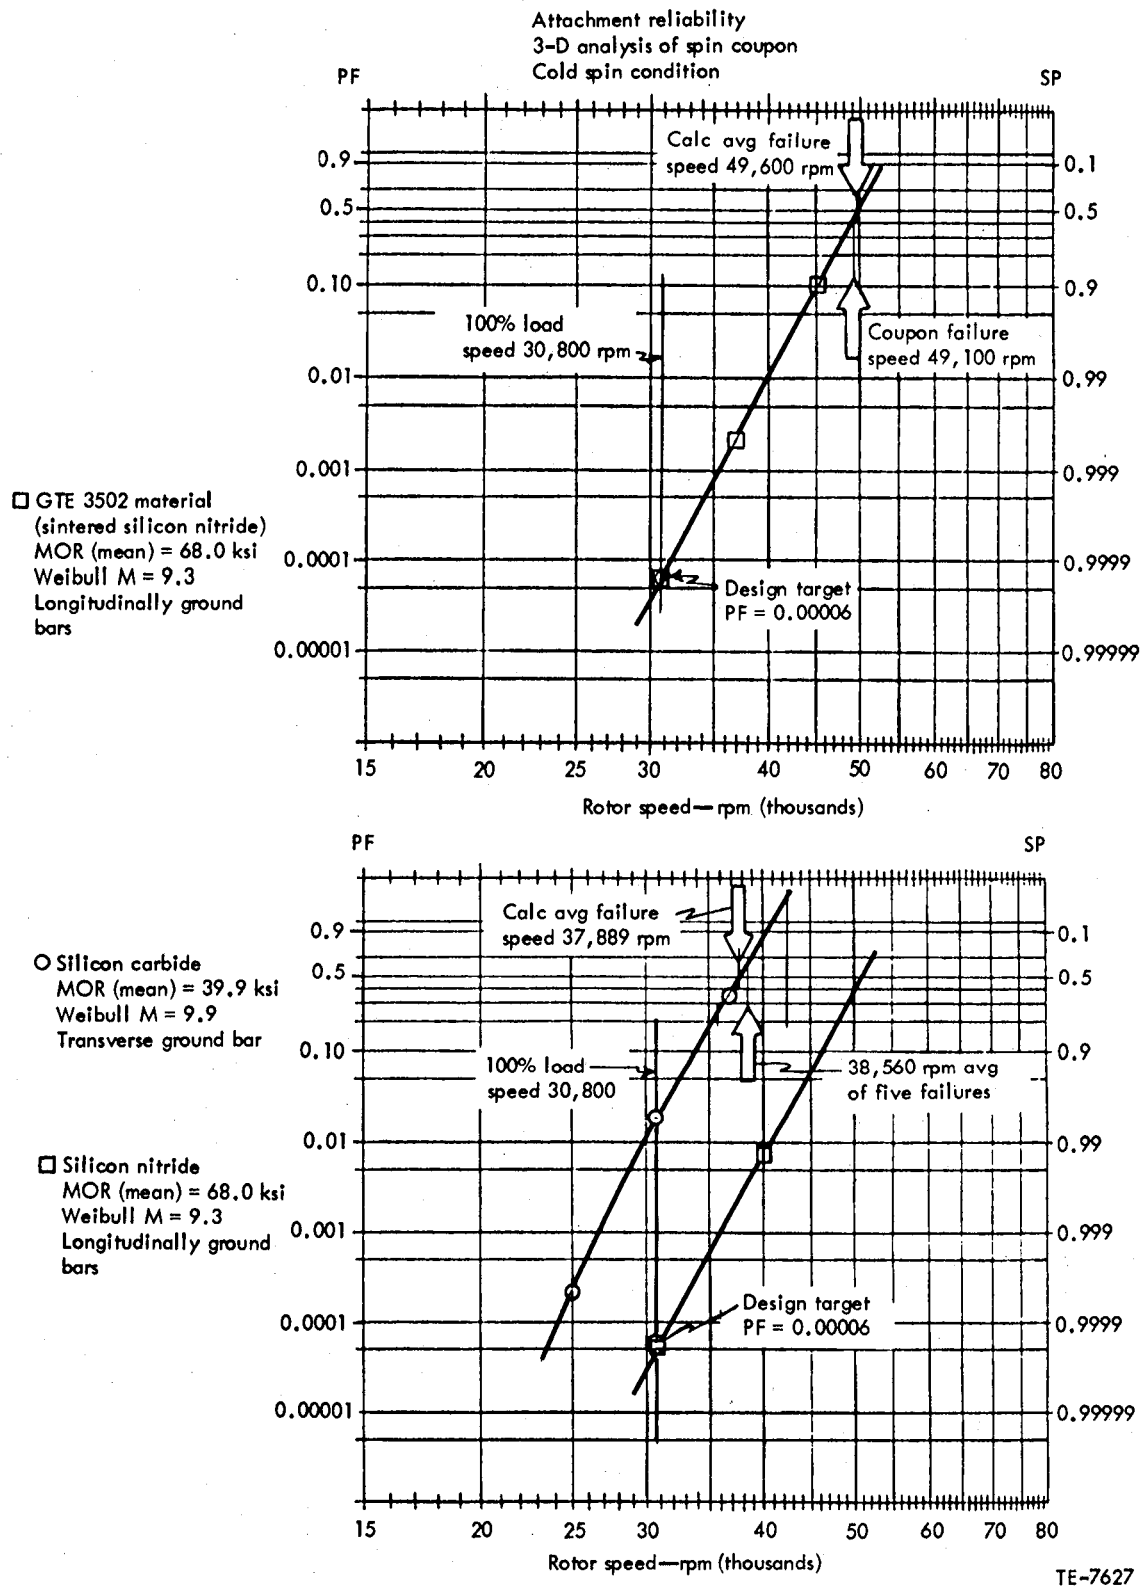
Room-temperature, overspeed-to-failure spin tests were conducted as the next logical step. Silicon carbide and silicon nitride slab coupons and the three candidate compliant layers were tested. The results, shown in Figure 312, included the following observations:

1. The five silicon carbide specimens with IN-600 compliant layer failed at an average speed of 38,560 rpm versus 37,889 rpm predicted (1.8% difference).
2. The use of IN-600, L605, or 347 stainless steel compliant layers does not affect failure speed in cold spin.
3. Failure initiation locations are very close to peak stress locations computed by 3-D finite element analysis.

Figure 312. Spin coupon reliability versus rotor speed.

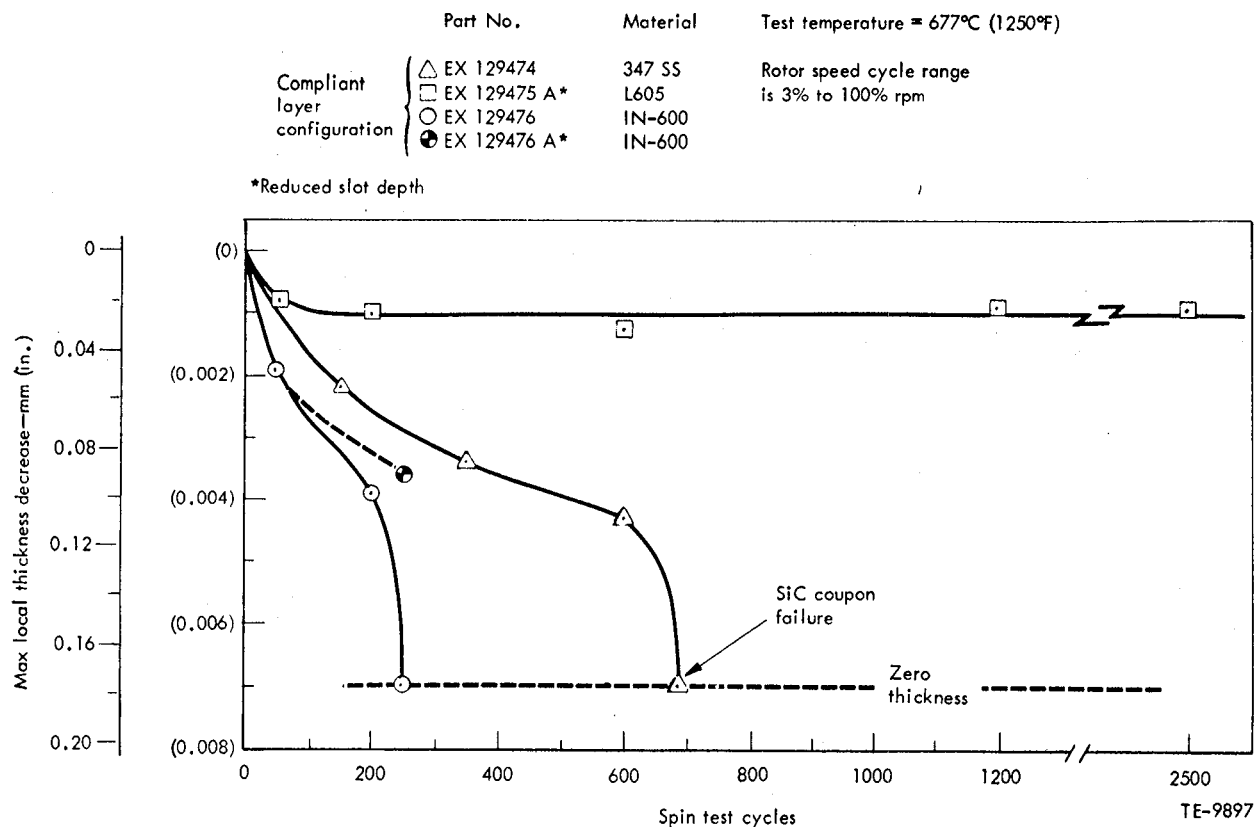
series, the rotor assembly temperature is maintained at 677°C (1250°F), and rotor speed is cycled between 500 and 30,800 rpm (100% attachment load speed). After each test, the compliant layer and coupon were photographed and thickness change of the layer was determined. Results of the thickness change measurements are in Figure 313. The photo-

- IN-600 Compliant Layer. This material seems to be compliant, but cyclic testing resulted in complete thin-out in 250 cycles. Considerable distortion of the layer is evident at 200 cycles.
- 347 Stainless Steel Compliant Layer. This material was also compliant, but excessive thin-out again resulted. Complete thin-out was skewed at 600 cycles and continued cycling failed the ceramic coupon at 684 cycles.
- L605 Compliant Layer. This cobalt-based material used in an annealed condition demonstrated minimal thin-out. After 2500 cycles, the maximum local thickness reduction was 0.02 mm (0.0008 in.). The initial annealed condition provides compliance, and the work-hardening characteristic provides resistance to continued thin-out. Based on these results, L605 was selected for compliant layers.

Figure 313. Hot cyclic spin evaluation of compliant layers.

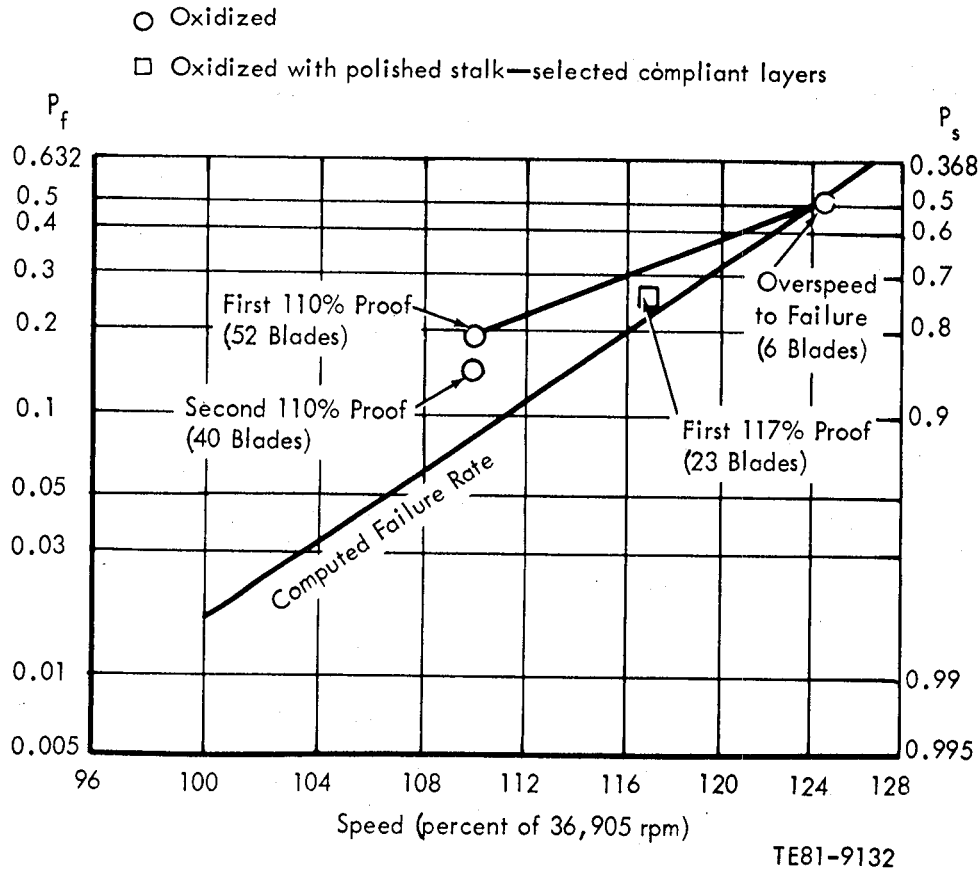
The additional spin evaluation was conducted, and the test failure rates (individual blades), presented in Figure 314 for comparison with the computed failure rate, were determined. The following observations were made:

- Six oxidized blades spun overspeed to failure had an average failure speed about equal to prediction.
- Fifty-two oxidized blades spun to 110% speed had a failure rate of nearly 20%, compared with 8% predicted rate.

- These two data points suggest that blade material mean strength is as anticipated, but Weibull modulus was lower than expected.
- The second 110% proof test of oxidized blades resulted in an additional 15% blade loss that cannot be explained by blade strength variability.
- The 23 oxidized and polished blades with selected-thickness compliant layers seem to have improved reliability at 117% proof speed. The achieved failure rate of 26% is still above the predicted 22% but below the 32% implied by the straight line between the oxidized-only data points.

Figure 314. Reliability of 2070°F-configuration blades.

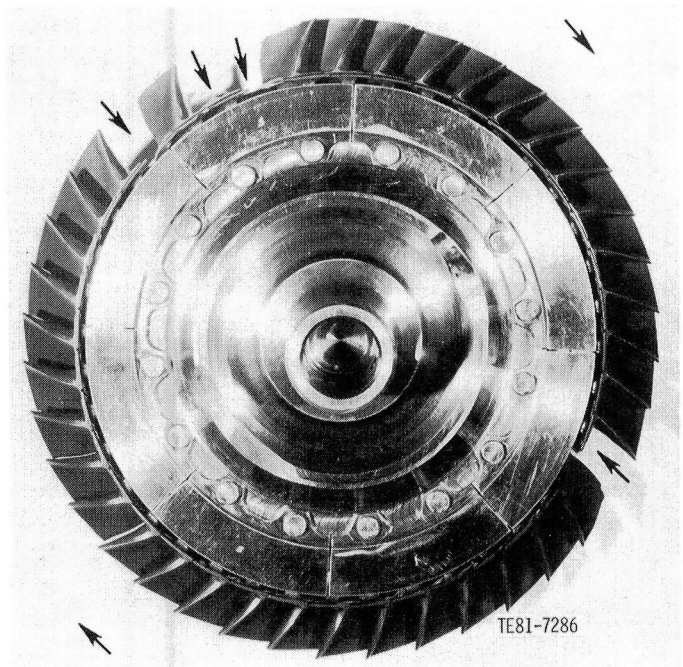
Rotor testing was accomplished in the evacuated spin facility previously used in CATE blade testing. The rotor was visually inspected after completing 5 minutes at 85%, 93%, 98%, and 103% speed. No abnormal conditions were noted. Failure occurred at 107% in an attempt to reach 108% speed. Four blades failed and three sustained damage at the blade tip, as shown in Figure 316.

Figure 316. Rotor assembly: proof test failure at 107% speed.

The interesting failure was the attachment at the 10 o'clock position, shown in Figure 316. The origin was located at the leading edge acute corner and was associated with an abnormal compliant layer contact pattern as shown in Figure 317. Proficorder traces of the failed blade and, for comparison, traces of a nonfailure are shown in Figure 318. Records revealed the major depression in the failed blade was due to polishing to remove a surface flaw. This nonuniform surface precipitated the failure. All other blades were checked and those with nonuniform contact pattern were replaced along with failed or damaged blades for the third rotor build.

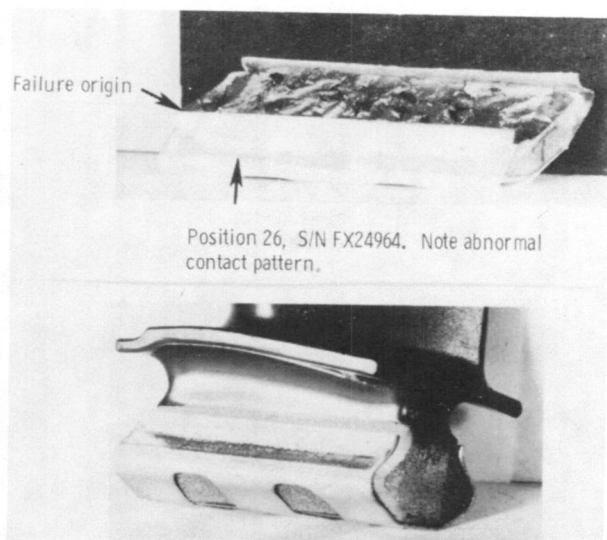
Figure 317. Attachment contact pattern.

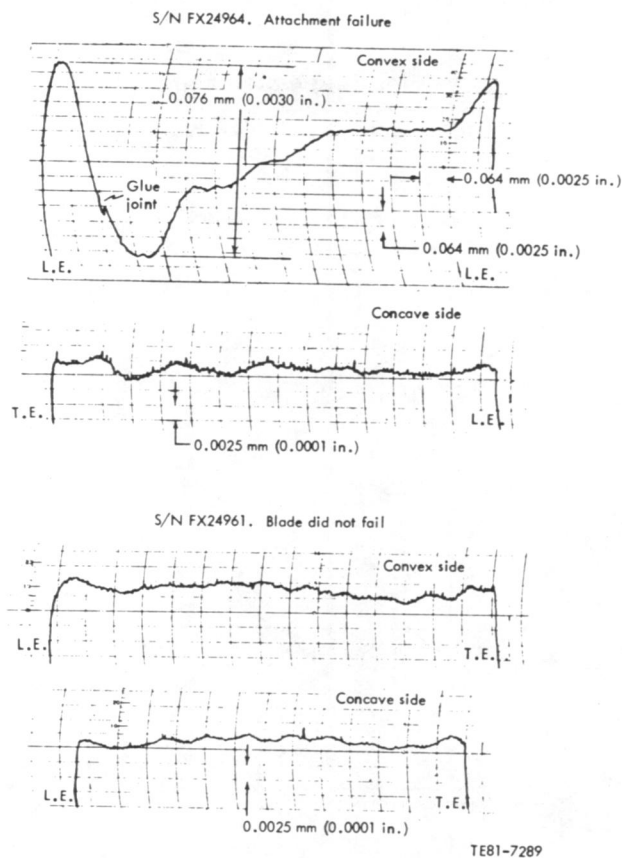
Figure 318. Proficorder data—dovetail contact surfaces.

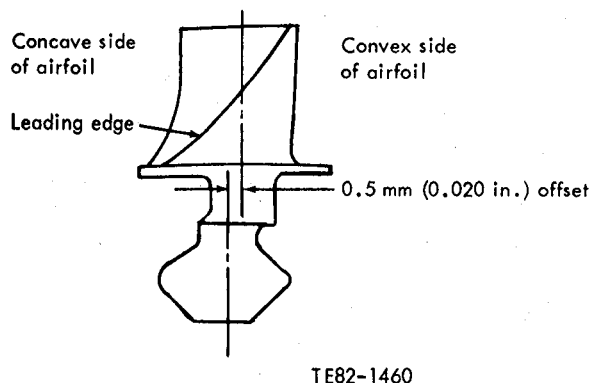
ever, the attachment center plane of the Crafts sample was typically shifted 0.5 mm (0.020 in.) relative to the airfoil, as illustrated in Figure 321. This was the result of indexing from one side of the blade to locate the blade in the matrix box. This technique was modified to check both sides to ensure centering (including the MPS sample).

Figure 321. GTE Si_3N_4 blade attachment machining.
